THE UNITED STATES  
STRATEGIC BOMBING SURVEY

THE ELECTRIC POWER  
INDUSTRY  
OF  
JAPAN

(Plant Reports)

Electric Power Division

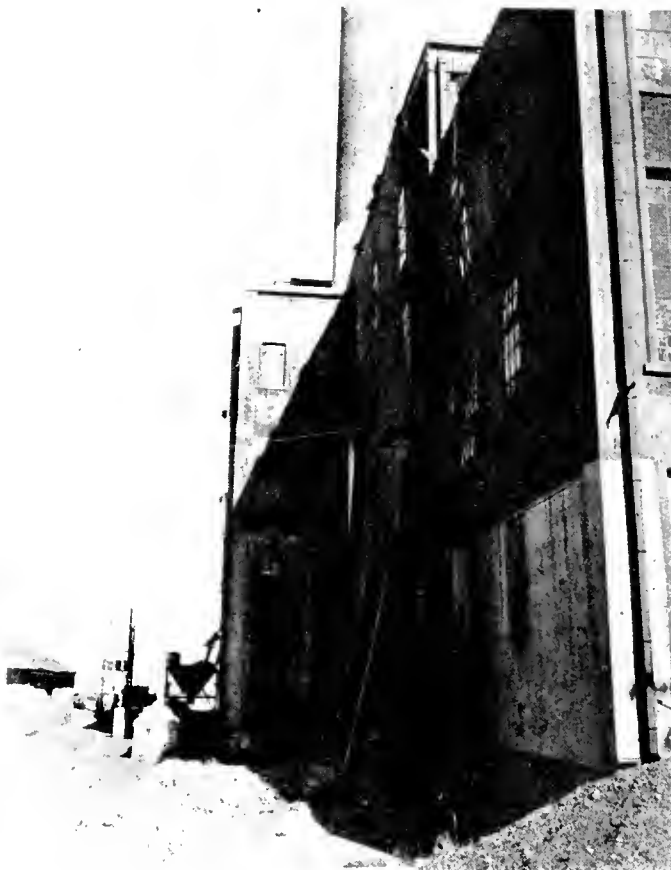
Photo 1—SAKA STEAM ELECTRIC STATION

End wall on NE end of section 2, station 1 (25,000 KW extension) showing blast from atomic bomb in Hiroshima, 2 and  $\frac{3}{4}$  miles away.

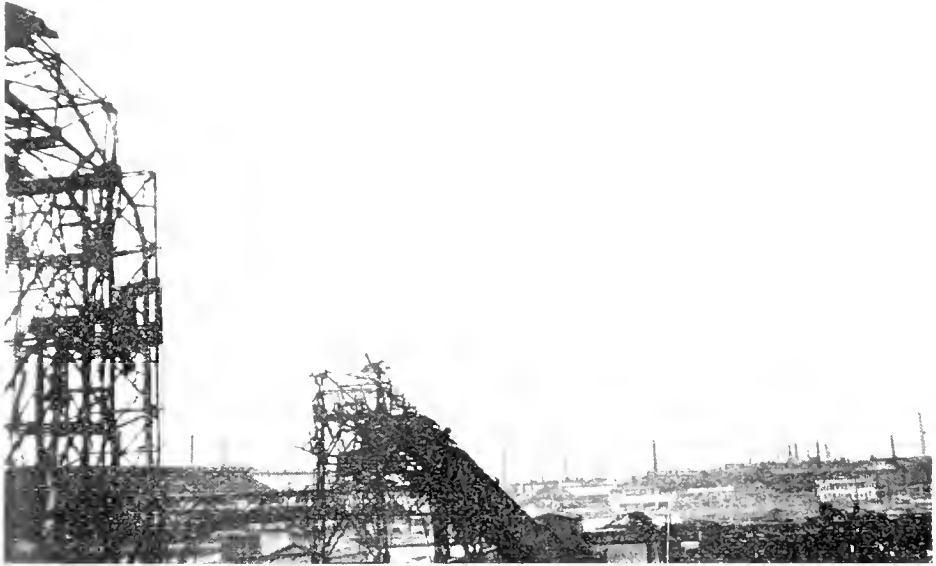
Photo 3—Direct hit on north coal conveyors looking north.

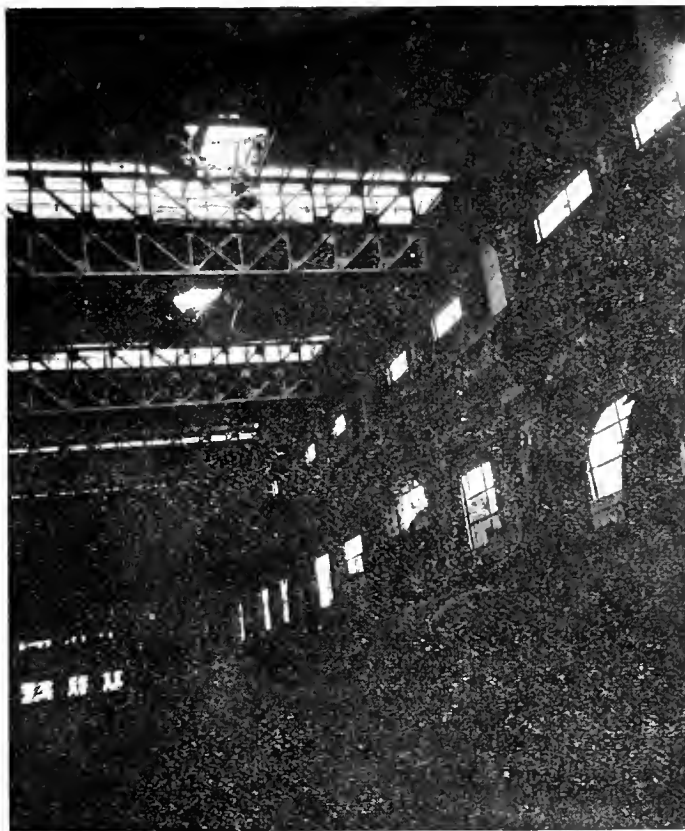
Photo 5—Two bomb hits on ceiling of turbogenerator room.

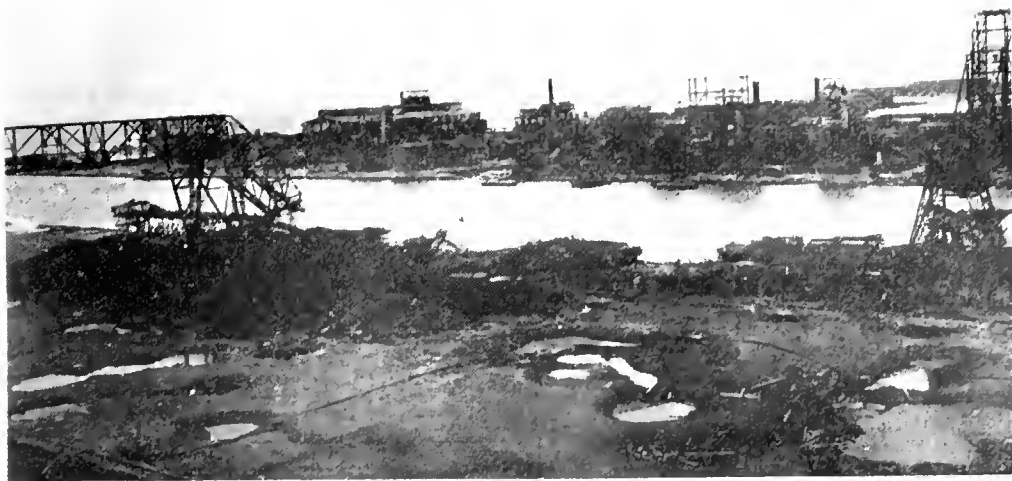
Photo 4—View looking west from top of boiler house showing damaged coal handling equipment with Nippon Oil Refinery across canal

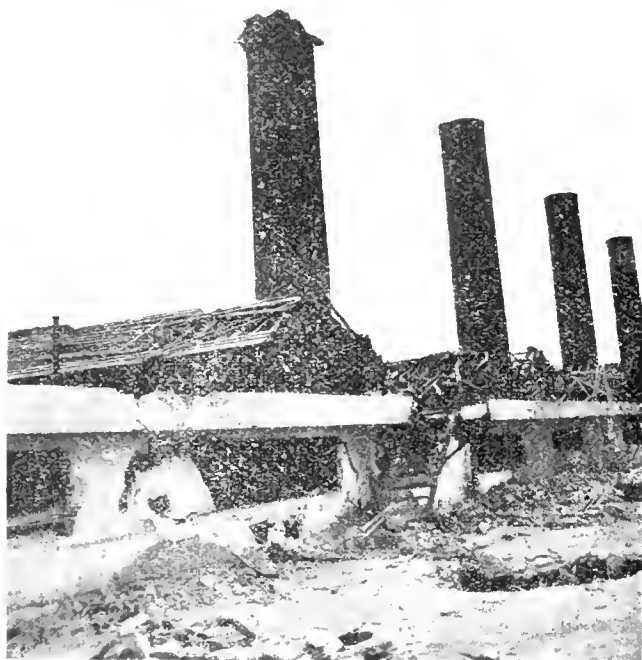
Photo 5—View looking south of damaged boiler house roof

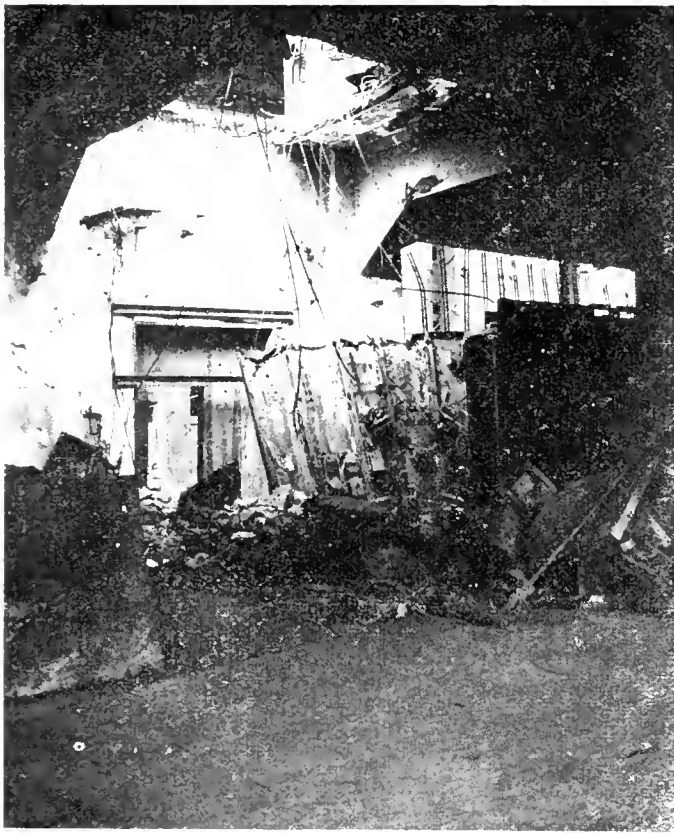
Photo 9—View of bomb hit in  
main control room

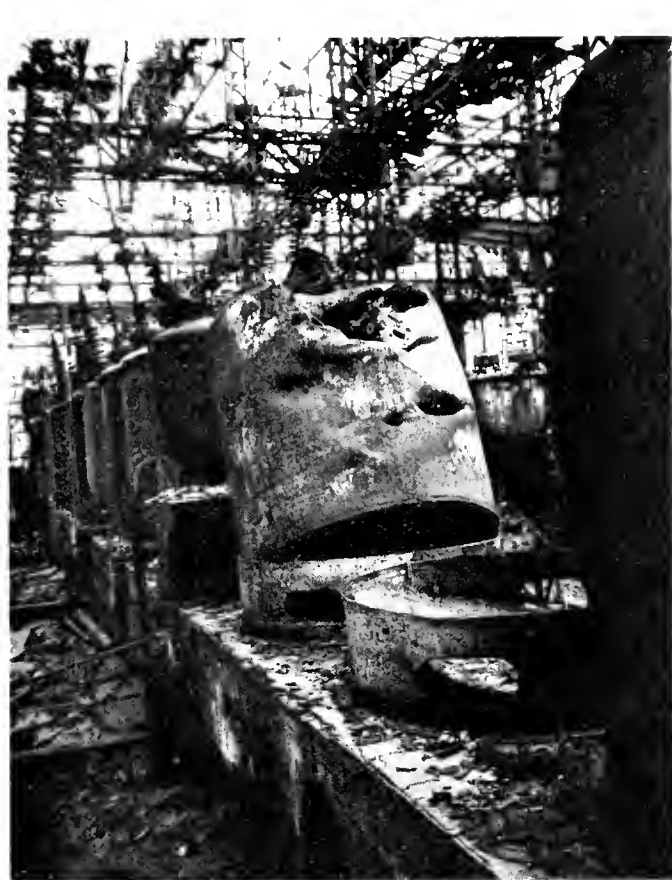
Photo 11—View of damaged oil circuit breaker

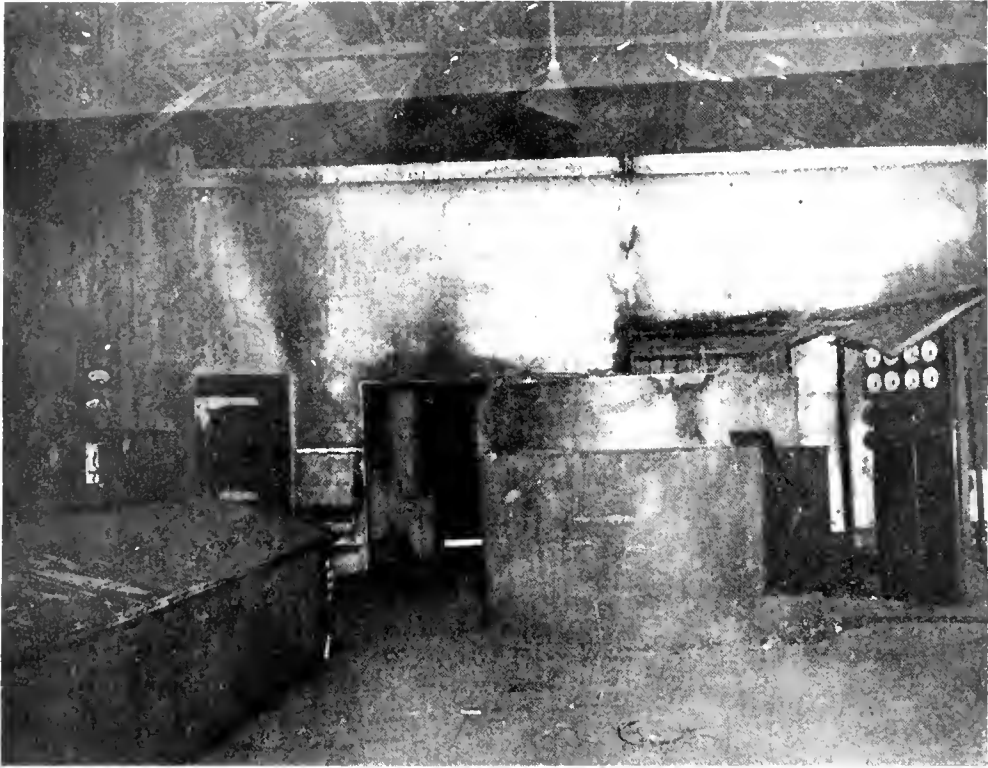
Photo 1—View showing damaged control desk and auxiliary panels and also damaged shelter

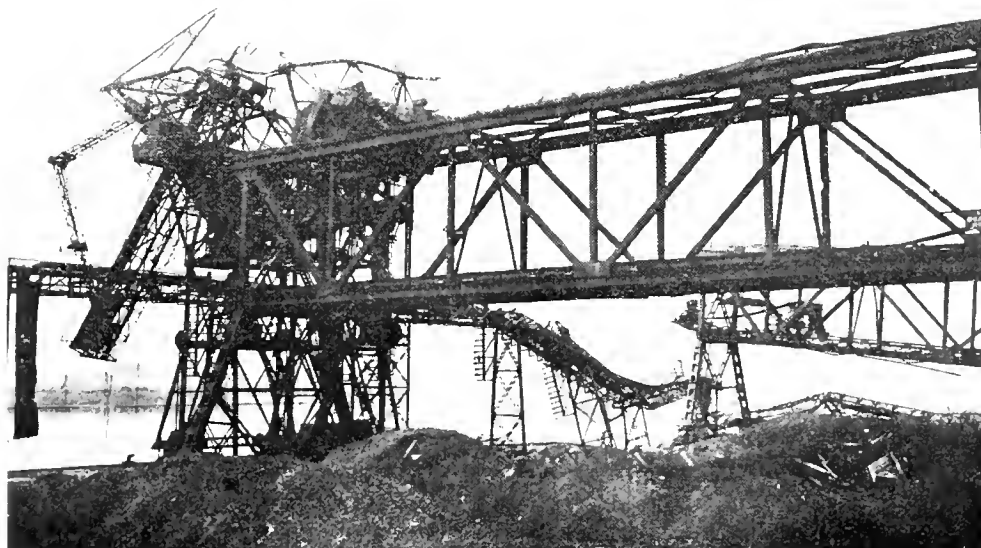
Photo 2—View of damaged unloading crane and conveyors

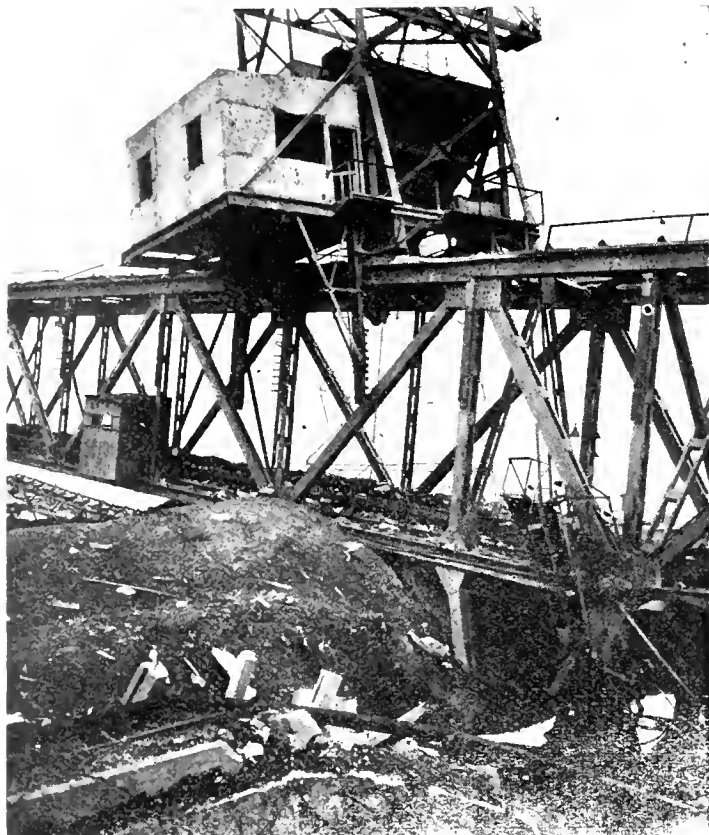
Photo 3—View of damage to traveling gantry crane in coal yard

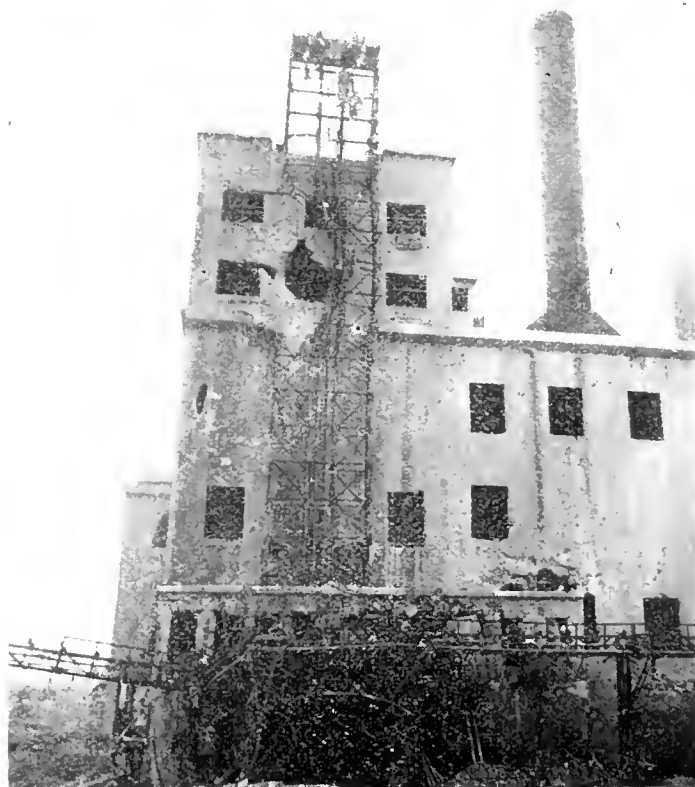
Photo 4—View showing damaged skiphoist and coal conveyor

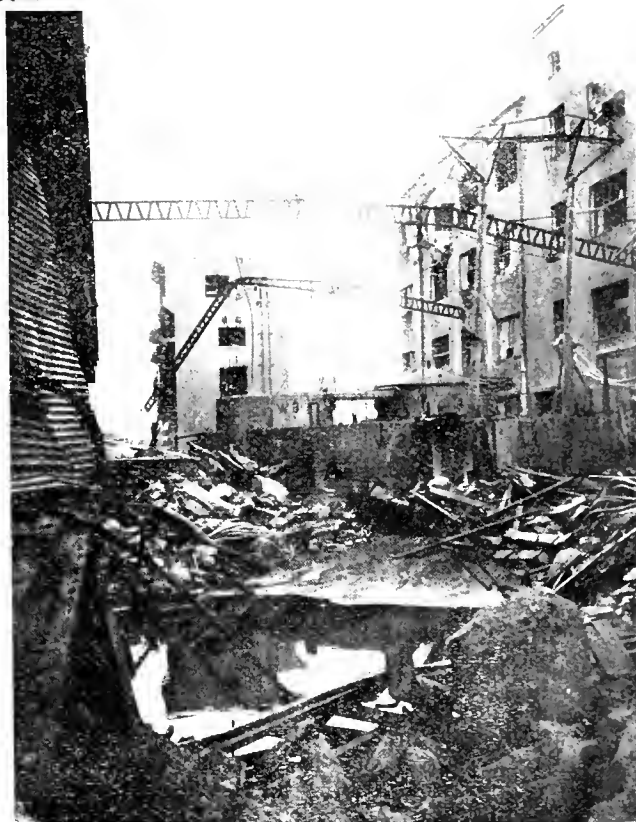
Photo 6—View showing bomb hit in space between turbogenerator bay and transformer house

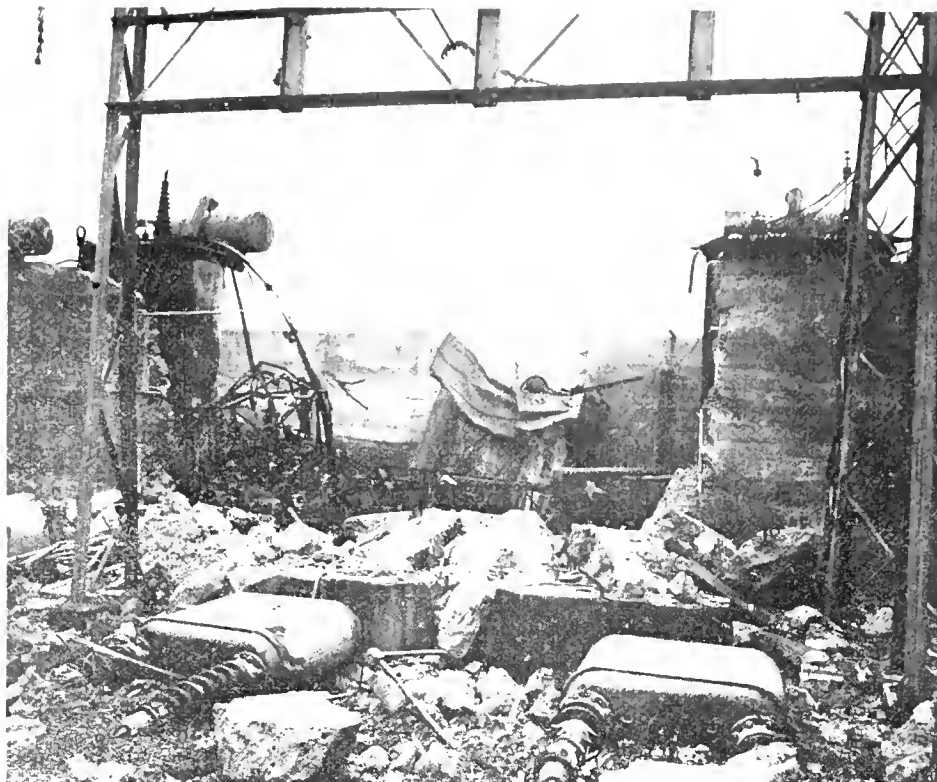
Only a minor amount of protective measures had been taken. The main buildings had been painted with an irregular pattern of black and white paint as camouflage. (Exhibit C, photos 4 and 7) The generators and turbines had been enclosed in a ring of dirt-filled straw bags. (Exhibit C, photo 14) Across the center of each generator hall had been placed a protective wall, about 8 ft high by 35 ft long, built of 2 sides of steel plates on angle iron frames placed about 12 in apart with the center filled with sand. (Exhibit C, photo 9) Concrete vaults for protection of workmen had been placed at various points throughout the plant. (Exhibit C, photo 8) Concrete, blast, protective walls were built around the large transformers in the open air transformer and switching station. (Exhibit C, photos 4 and 5)

Photo 5—Rear view main transformer bank —note protective wall —Raid number 1

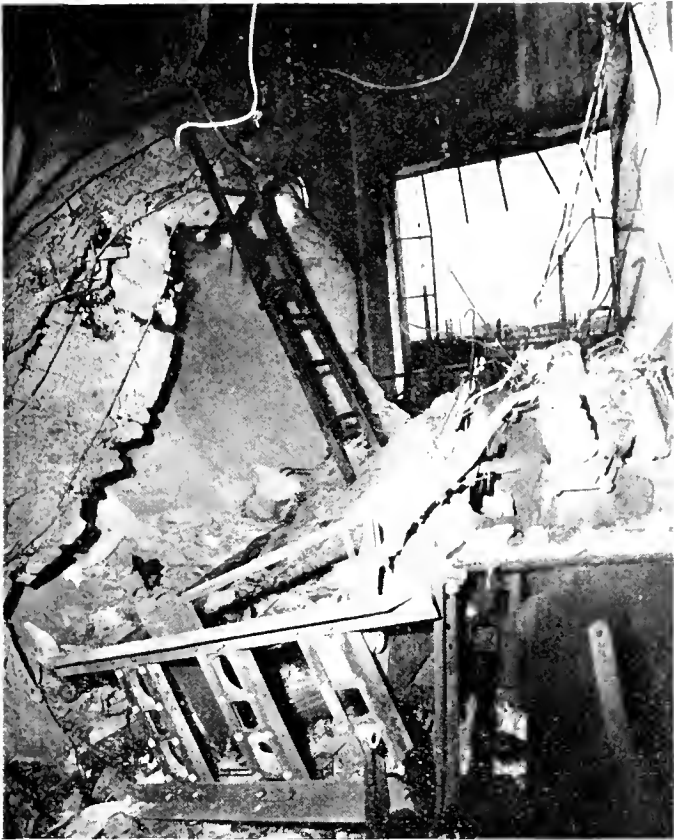
Photo 1—Close up view of damaged buss-run

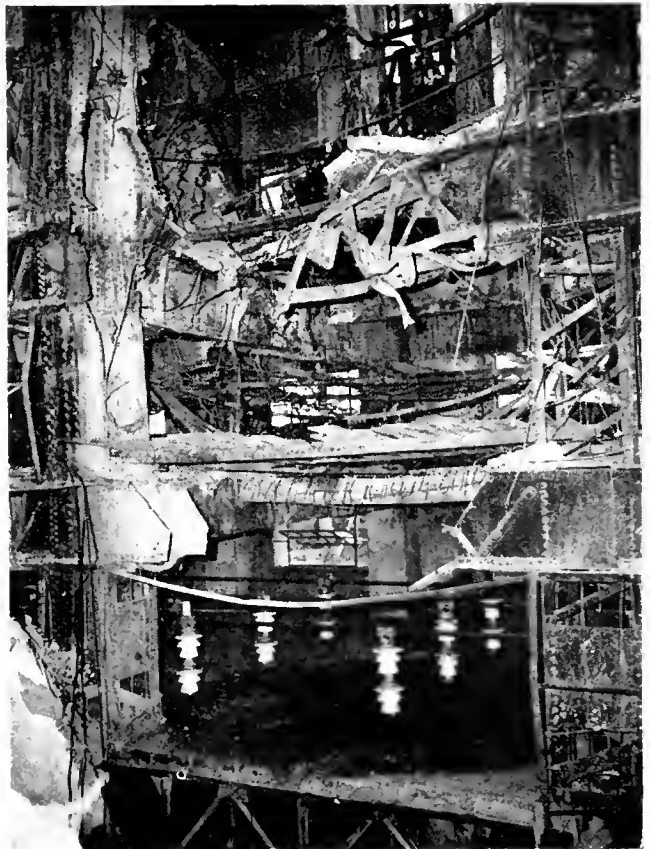
Photo 2—General view showing damage to  
busses and cables

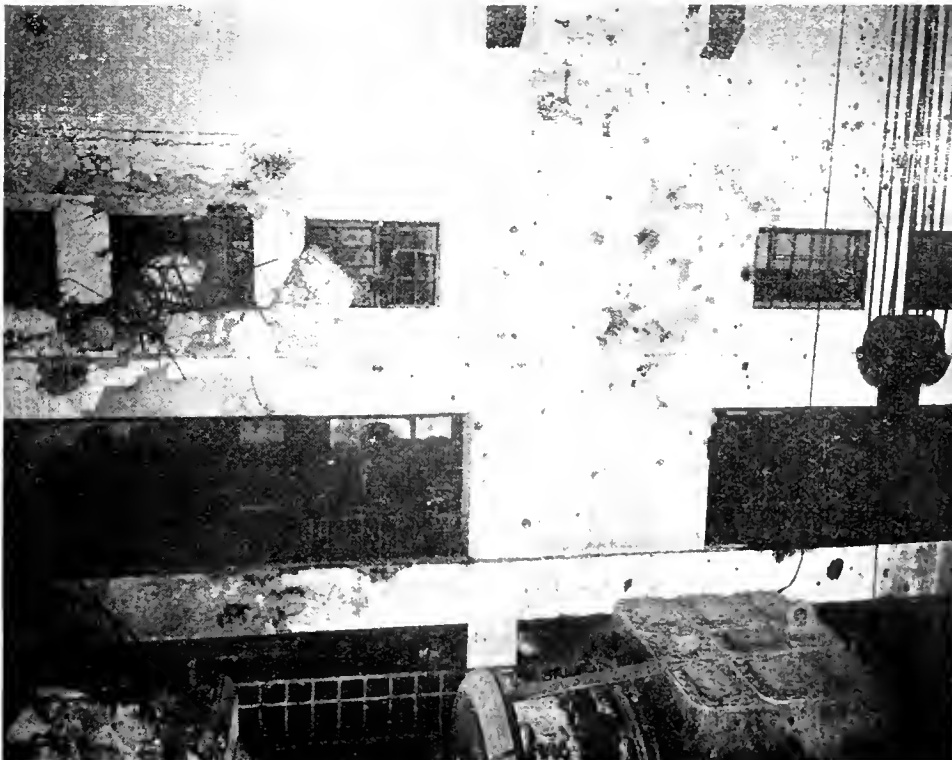
Photo 6—Fragmentation effect in interior of generator hall

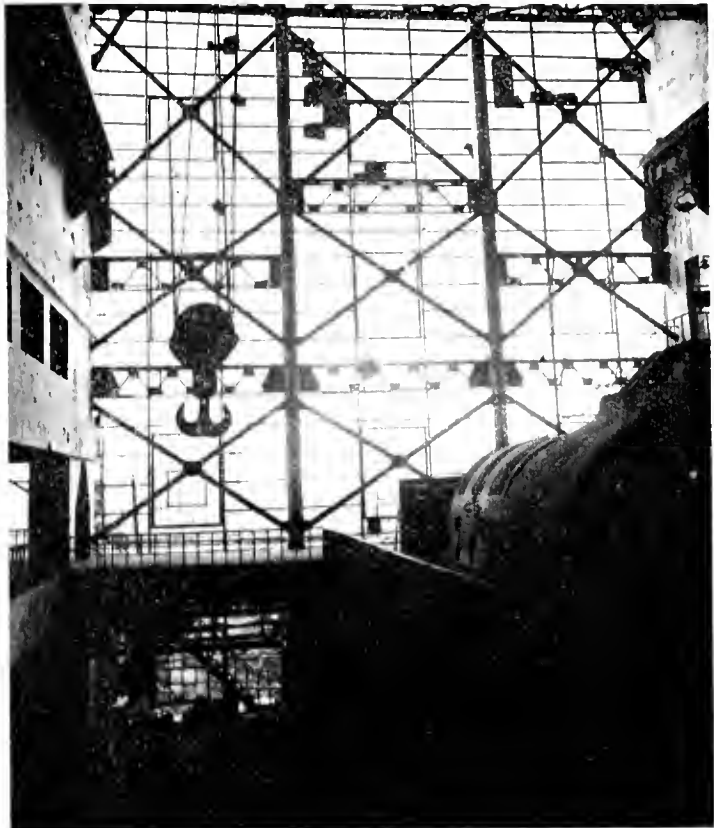
Photo 8—Damaged crane scale in generator hall

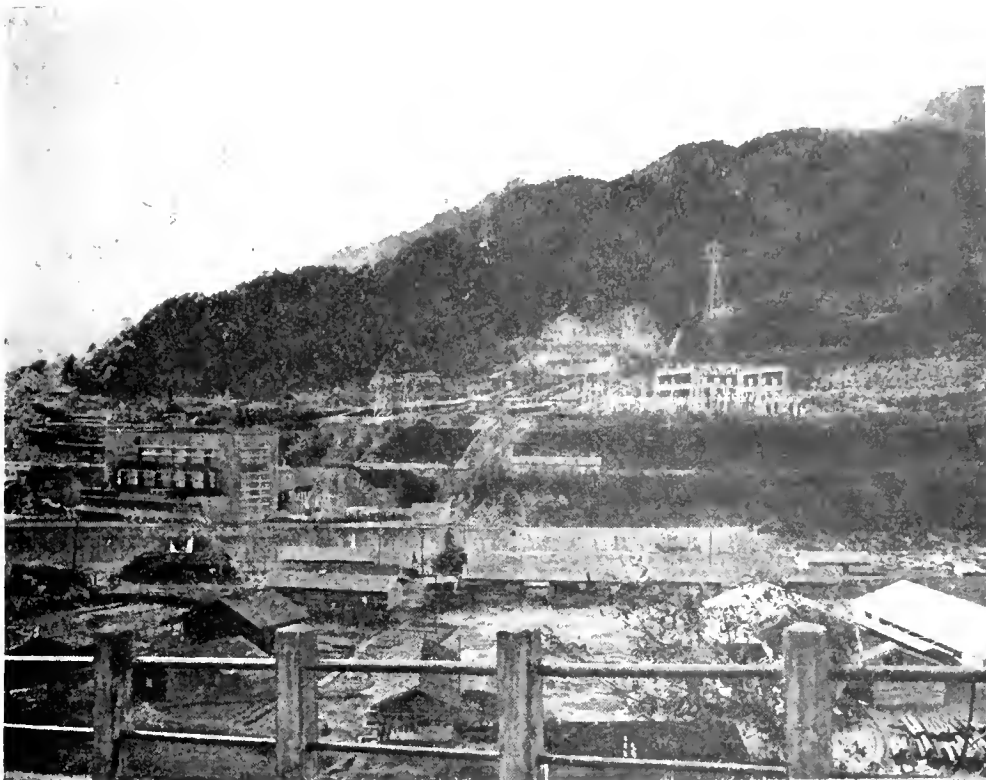
Exhibit C, photos 3 and 4 show the Outake plant. Photos 5 and 6 show the Tokiwa plant, and photo 14 shows the Suhara plant.

Photo 6—Tokiwa Power Plant (during construction)

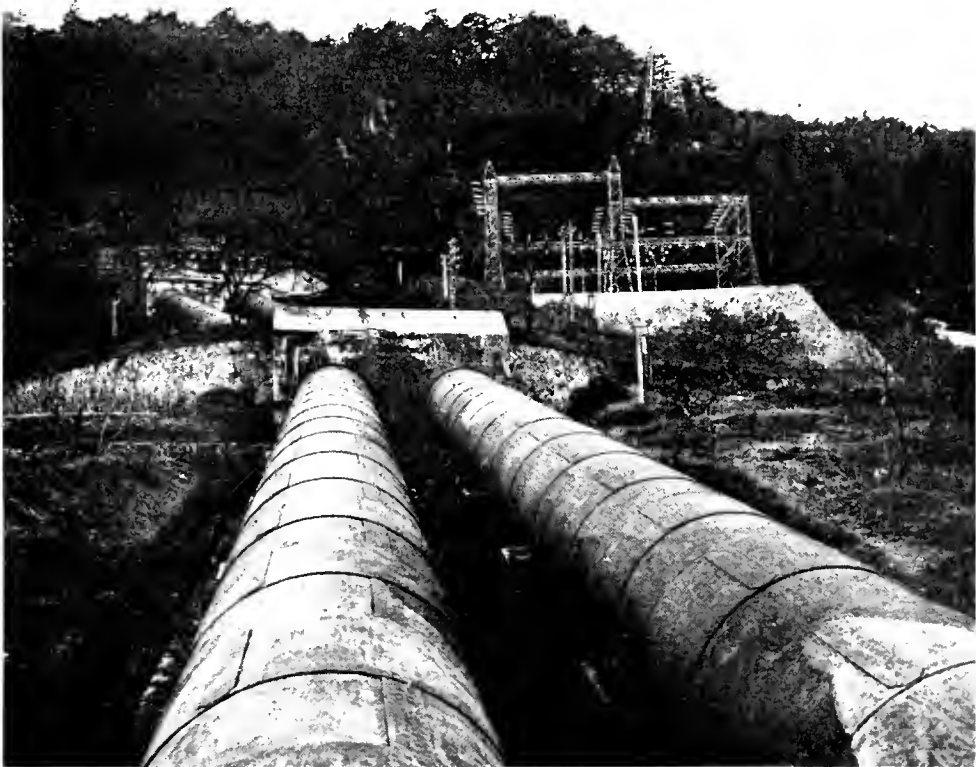
The Momoyama plant was completed in November 1923. (Exhibit C, photos 10 and 11). Water from the Kiso is diverted by a concrete diversion dam through a tunnel 1,400 ft in length to a head tank and there by 2 penstocks (Exhibit C, photo 12), each approximately 660 ft long, to the plant. No appreciable water storage is effected by the dam. The effective head is 260 ft, and the water quantity used is 1,300 cu ft/sec. There are 2 Escher Wyss, single-wheel, vertical-shaft turbines with Westinghouse generators, each rated 15,000-KVA at 80 percent PF, and double frequency of 50/or 60-cycles. The total name plate capacity is 24,000 KW, but the plant is rated at 24,600 KW. The main transformer and switching station is located outdoors (Exhibit C, photo 13); the transformers are adjacent to the station, and the switch yard is a short distance away at a higher elevation. There are six 5,000-KVA, 6.6/77 KV, single-phase, oil-immersed, water-cooled transformers and one spare, and the energy is supplied to the 77-KV, Okuwa, transmission line to the Rokugo substation at Nagoya. This station formerly had rotary frequency converter equipment in order that 60-cycle current generated in the hydro plants further down the Kiso River could be changed to 50-cycle in order to supply energy to the 50-cycle section of Japan. This was removed in October 1944 in order to reinstall it in Kyushu where it was greatly needed. According to information received but not verified, the installation in Kyushu has never been completed.

Photo 10—Momoyama Power Plant—General view

Photo 11—Momoyama Power Plant general view from penstocks

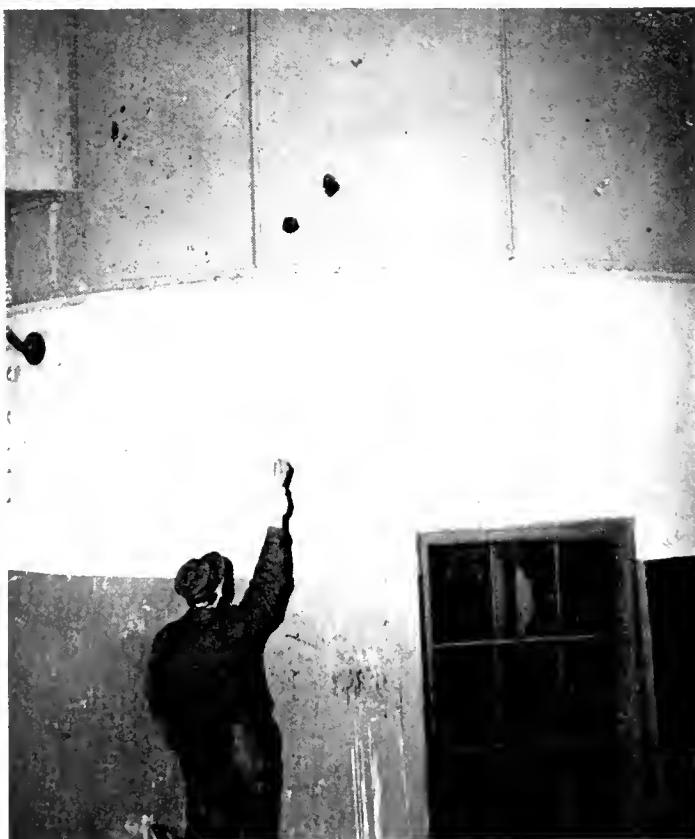
2. The plant was never a primary target, but was damaged on 30 July 1945 by carrier-based Navy planes unable to reach their planned objective. One 250 lb fragmentation bomb hit near the turbine room, damaging one generator and destroying a regional load dispatcher's office building, and 50-cal strafing punctured in several places the surge tank above the penstocks.

Photo 4—Bomb fragment holes in generator housing

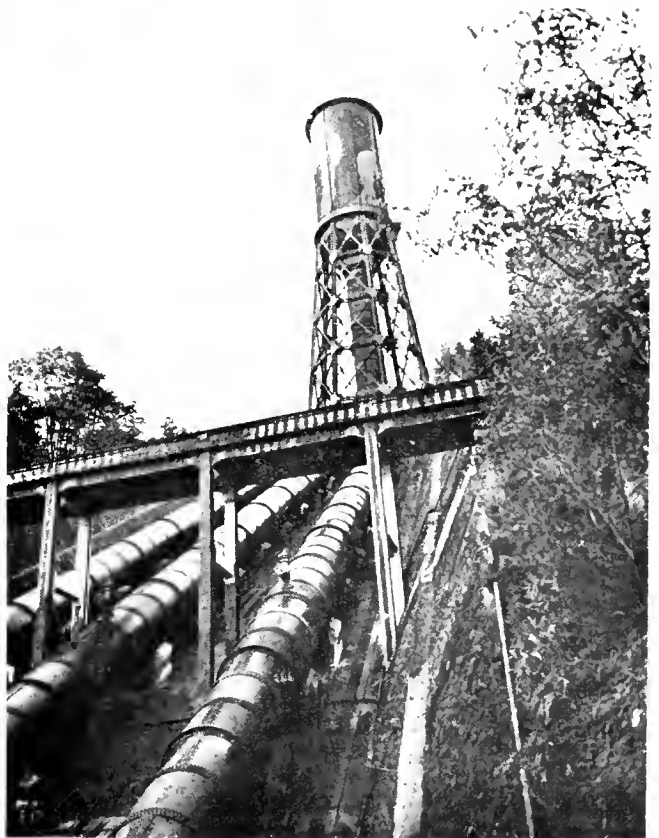
Photo 6—Tank (damaged by strafing) and penstocks

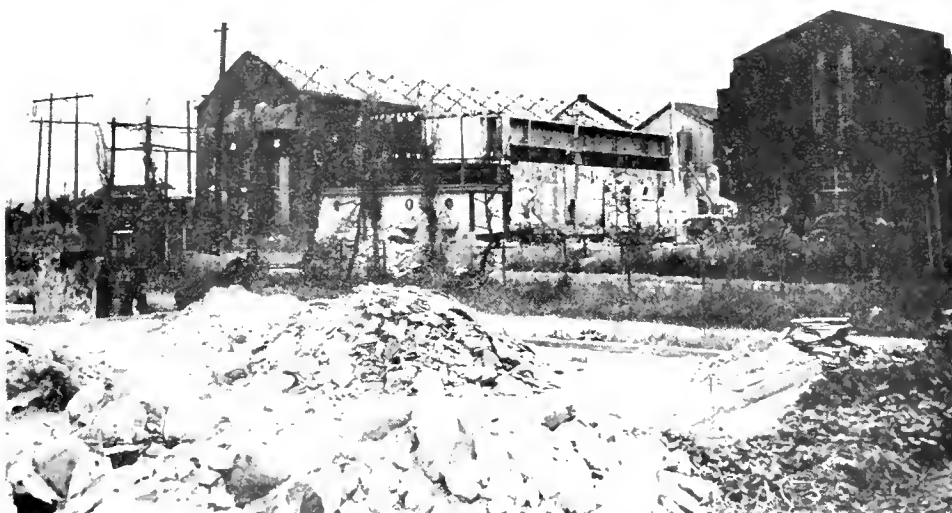
room (Exhibit B, photo 18), the transformer room housing the group of 2,500 KVA transformers, as well as the 10,000-KVA, 3-phase transformer located adjacent thereto. (Exhibit B, photo 19). All the oil circuit breakers, the control board (Exhibit B, photo 17), and the transformers were put completely out of service, and while minute examination has not been made, it is expected these are all completely ruined. The 10,000-KVA transformer will require a complete rebuilding. The three 4,000-KVA transformers were not damaged and were placed back in operation on 22 July 1945. This is the only portion (except the synchronous condenser) of the station that was not badly damaged. All the load sheets were destroyed by fire, but officials advised that the station was carrying a load of about 32,000 KVA, and, since restoration of the one remaining transformer bank, the load is from 2000 to 2300 KVA. No protective measures of any kind had been taken. Complete repairs to all equipment and buildings will require at least six months.

Photo 16—Rokugo—General view of damaged station

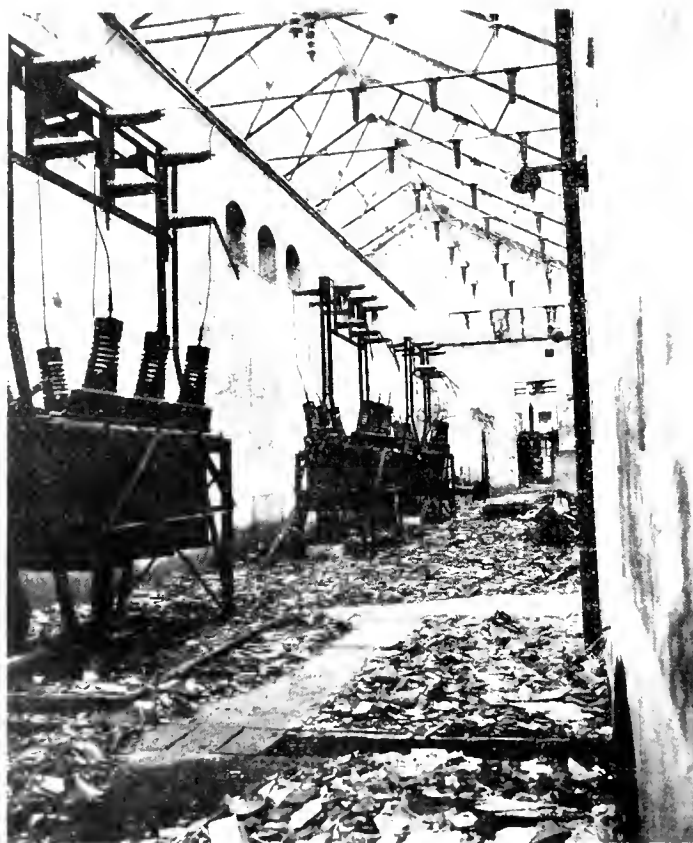
Photo 18—Rokugo—77-KV oil circuit breakers destroyed by fire

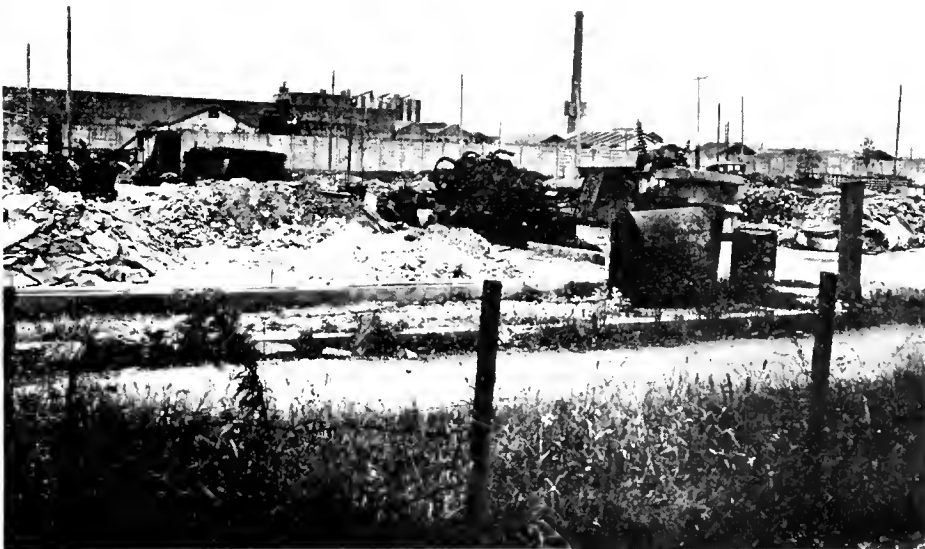
Photo 20—Rokugo—General view burned electrical storeroom adjacent to substation

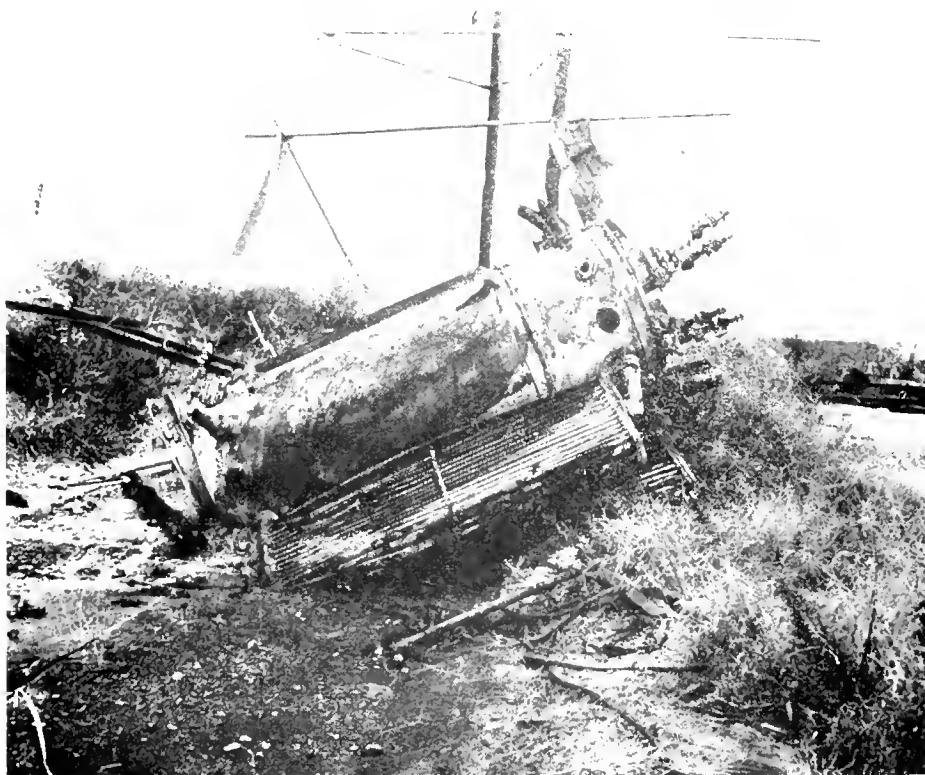
Photo 22—Taiko—Transformer No 1 of destroyed bank

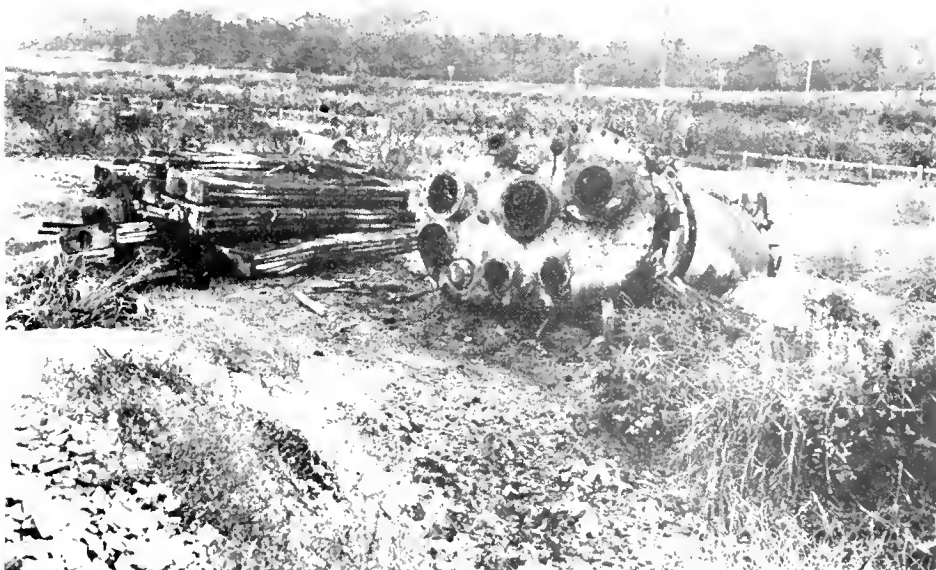
Photo 24—Taiko—Transformer No 3 of destroyed bank

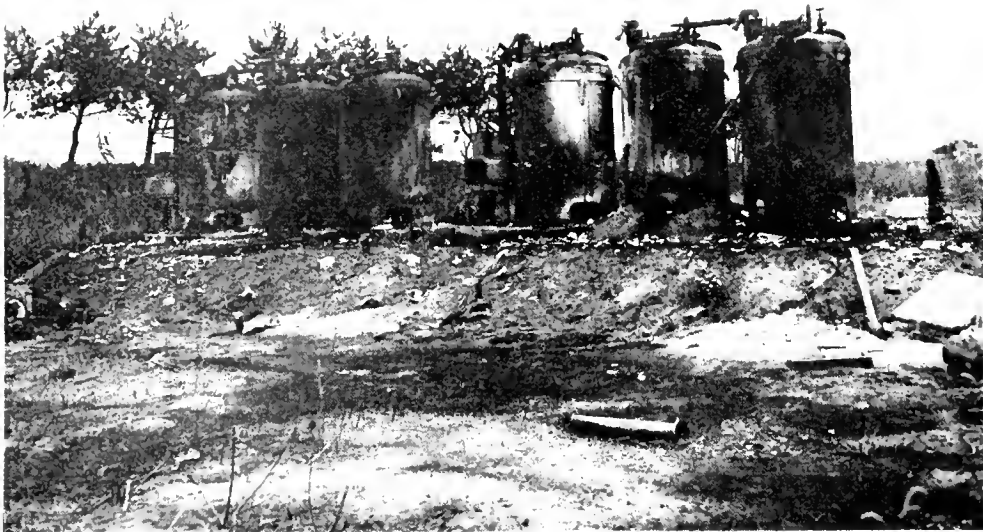
Photo 25—Taiko— Destroyed group of oil circuit breakers

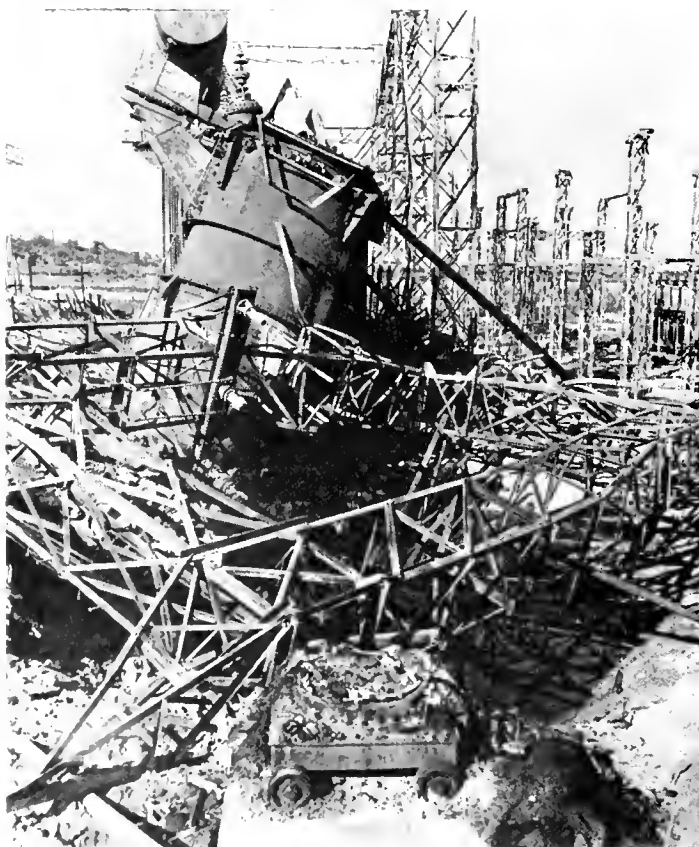
Photo 2—Bomb crater from direct hit at end of transformer bank

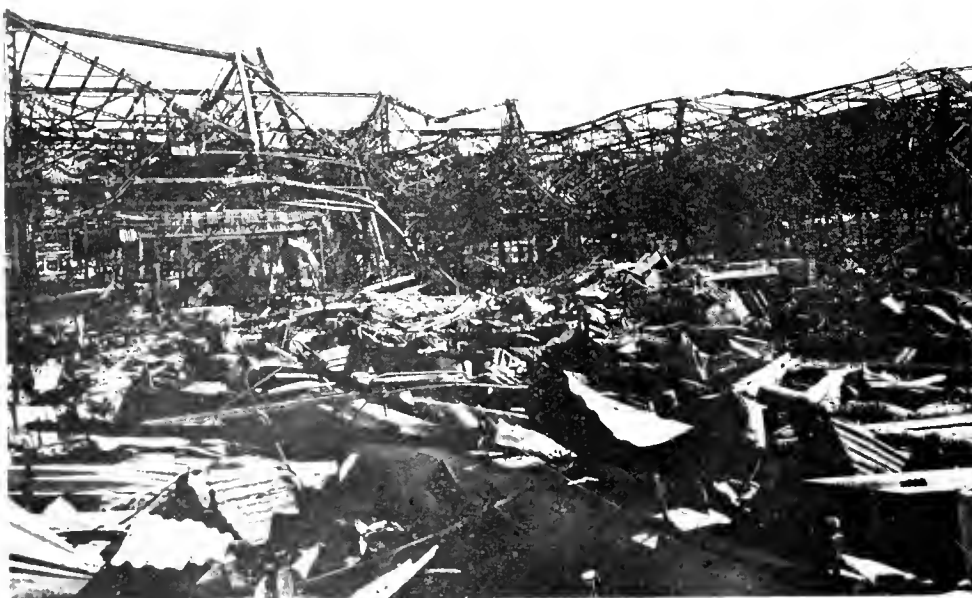
Photo 6—View of damaged manufacturing building near Sakurajima substation

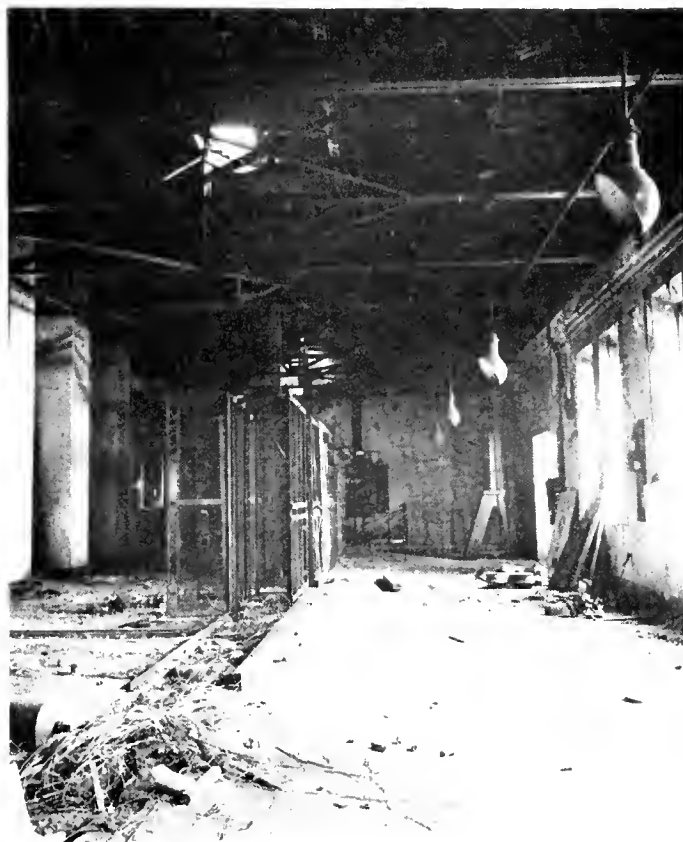
Photo 8—Dotombori substation-view showing damaged control panels and control wiring, part in foreground removed

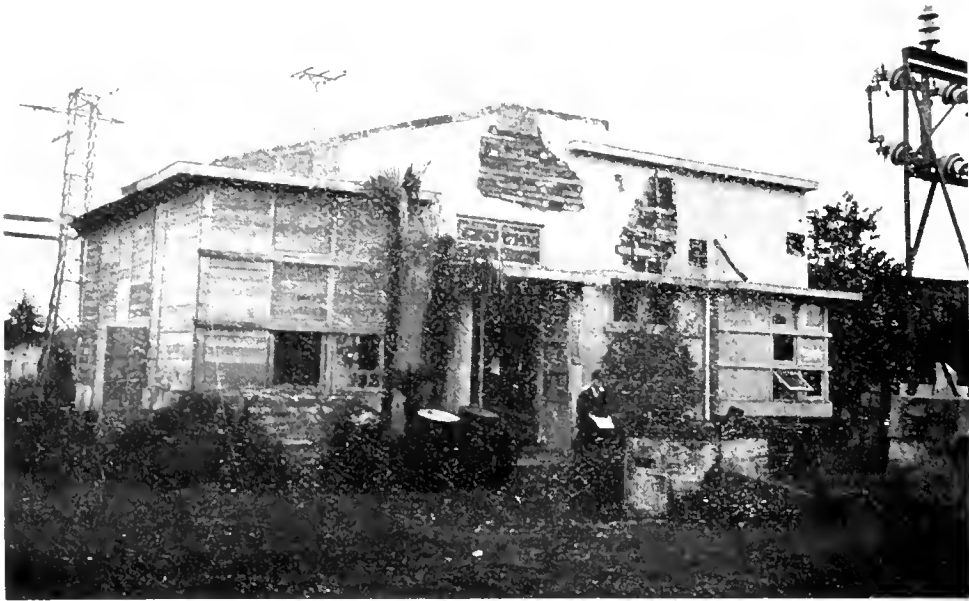
Photo 1—Chigasaki substation—front view of building showing 50-cal penetration. The building on front left is temporary new building. Bomb shelter in left foreground

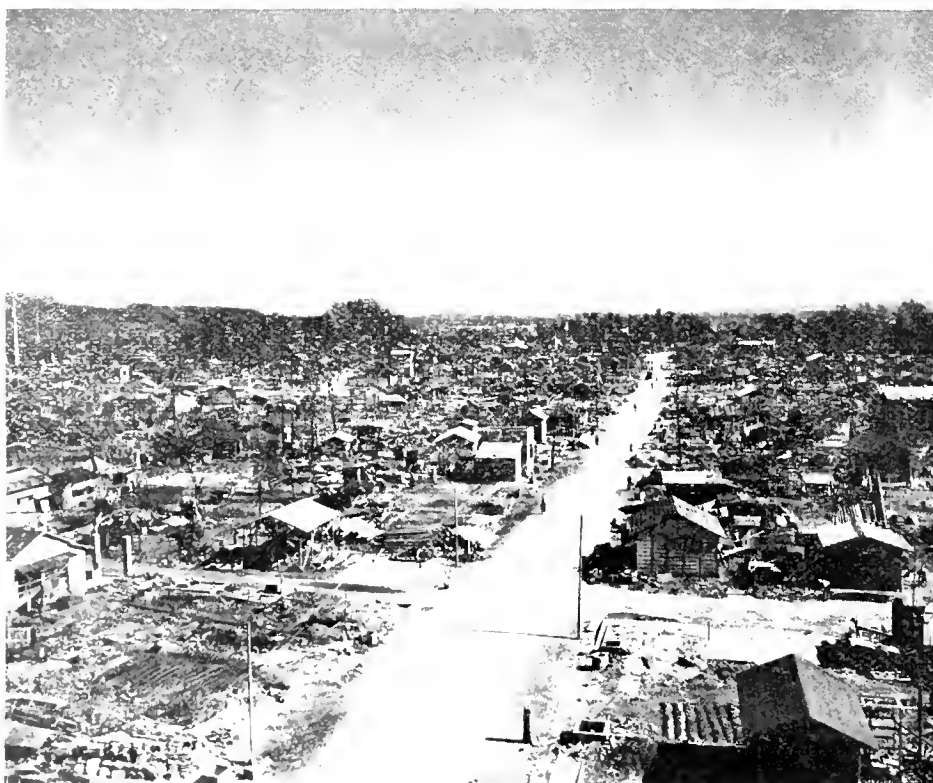
Photo 10—Hachioji substation —Area around station showing crowded, inflammable buildings.  
Buildings shown have been built since the area was destroyed by fire on 2 August 1945

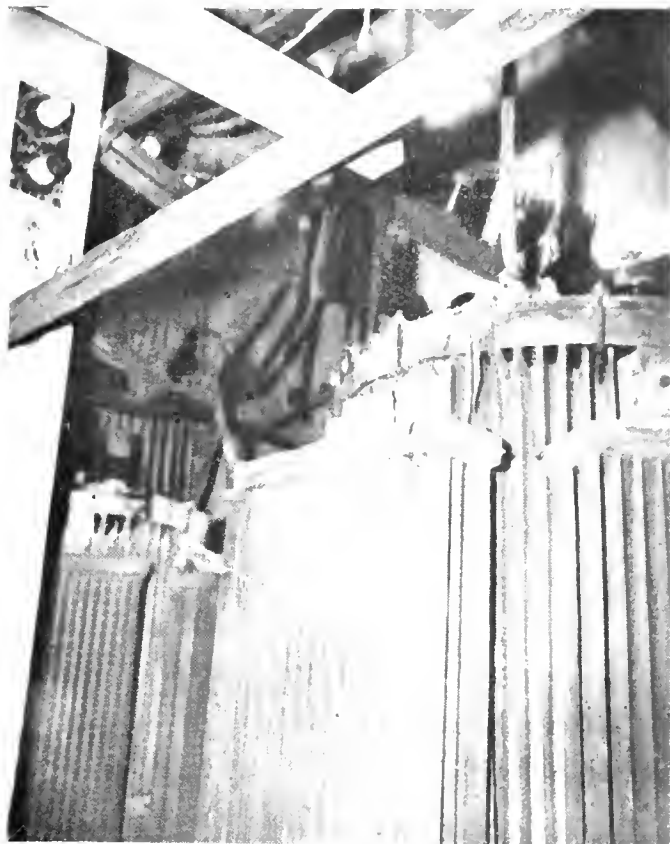
Photo 18—Kojimachi substation—Transformer and bus structure damage on first floor

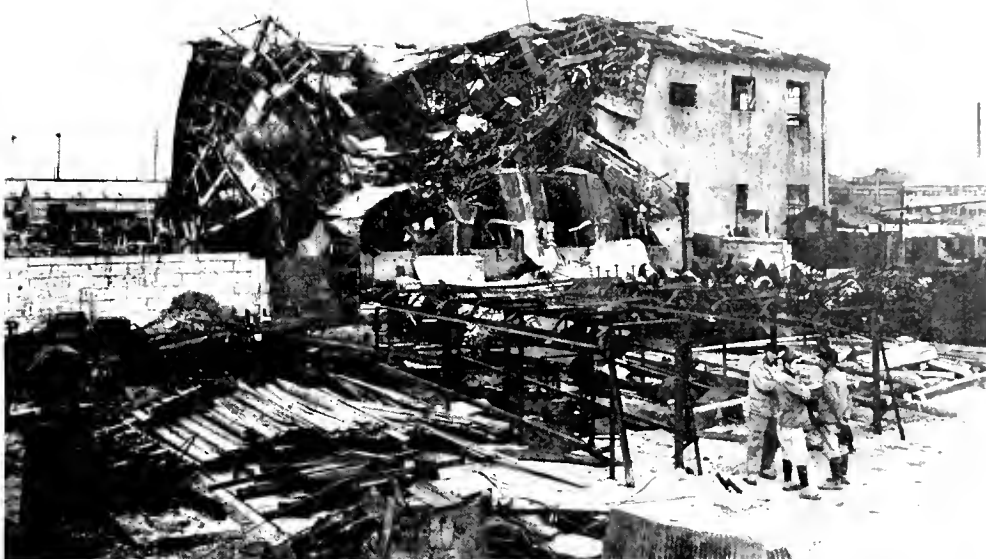
*Principal physical damage*—One of the incendiary bombs penetrated the transite roof and landed on the transformer floor near one of the transformers. The ensuing fire completely destroyed the transformers, all other electrical equipment, and the building. (Exhibit A, photos 21 and 22).

Photo 21—Nippori substation—General view of station. Incendiary bomb penetrated roof in center foreground

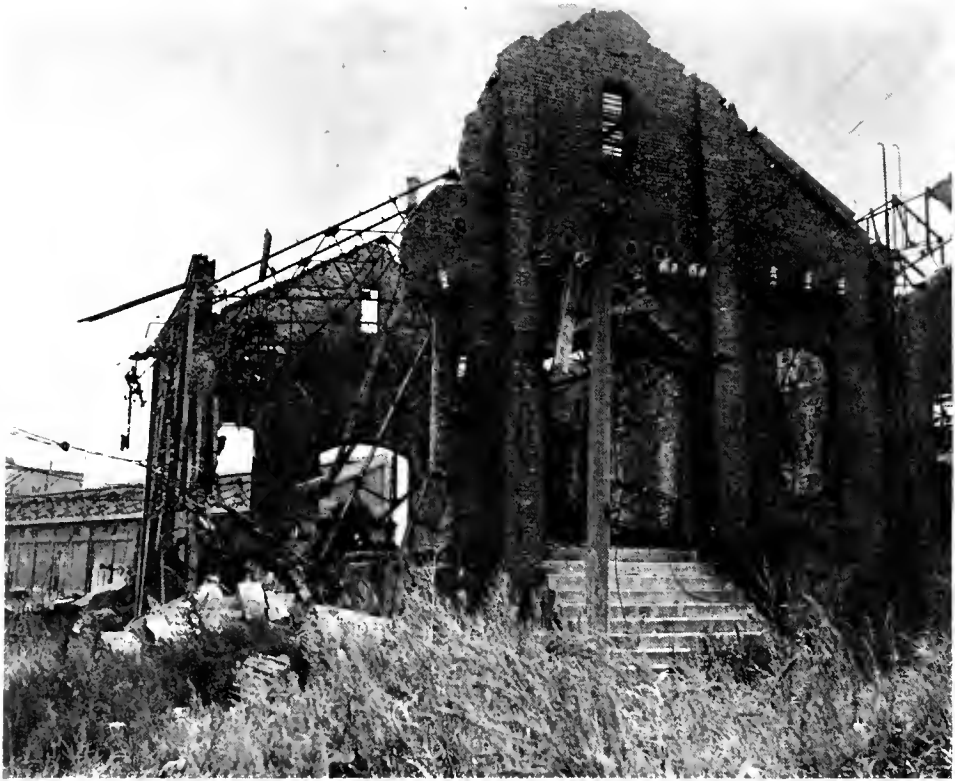
*Attacks*—This station was not a primary target, but, on 14 April 1945, during an area raid, there was a direct HE hit on one corner of the building, demolishing the side of the building and a corner of the roof. (Exhibit A, photo 33) Subsequent IBs hit the adjacent territory.

*Principal physical damage*—The HE did considerable damage to the building, but practically none to the electrical equipment. The IBs dropped on the adjacent area started fires that spread to the substation. The fire completely destroyed all the electrical equipment and the station is beyond repair. (Exhibit A, photos 31, 32 and 33)

Photo 33—Sugamo substation—Rear corner of building where HE bomb hit
